ES_LPC18S50/S30/S10

Errata sheet LPC18S50, LPC18S30, LPC18S10

Rev. 1.6 — 20 April 2016

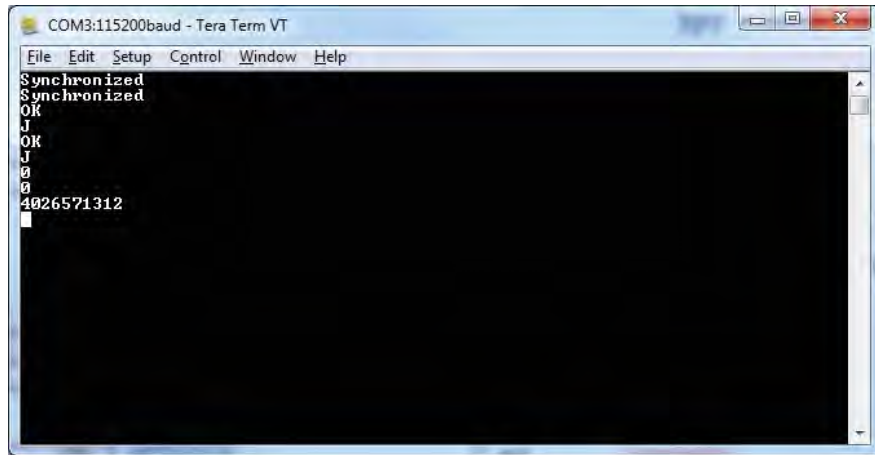
Incorrect example:

The 'J' command in ISP mode should return an error code, followed by an ASCII string representation of the part ID, followed by a 0. However what is actually returned is the error code, followed by a 0, followed by an ASCII string representation of the part ID. The problem is the last two items returned are swapped.

There is no work-around for this problem.

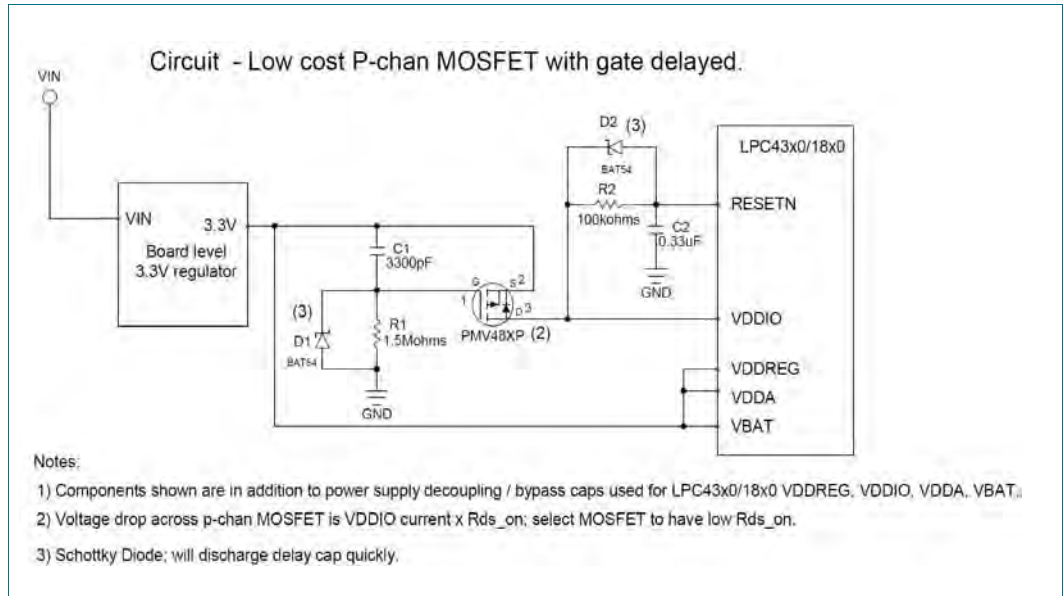
On all packages, repeated power cycling of the device may cause erroneous programming of the OTP banks. During ramp-up, the VDDREG supply voltage does not have enough time to settle and initialize the OTP controller before valid programming voltage is reached on the VPP pin. This may cause accidental programming of the OTP banks. Accidental programming of the OTP banks does not occur during Power-down of the supply voltage.

- Do not tie VDDIO to VDDREG and VDDA pins. The power supplied to the VDDIO pin should be delayed by 2 ms after the power supply on the VDDREG and VDDA pins stabilizes at the operating voltage level. The signal to the RESETN pin must also be delayed by 2 ms after the power supply on the VDDIO pin stabilizes at the operating voltage level.

The following circuit diagram is an example that shows the P-channel MOSFET with the gate delayed and the R-C delay circuit connected to the RESETN pin.

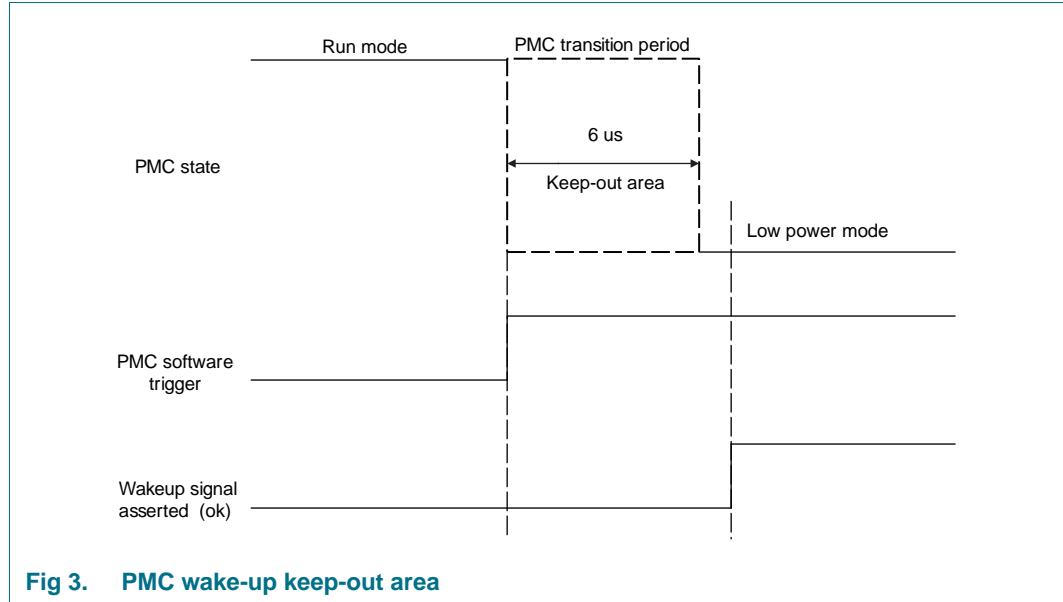
Fig 3. PMC wake-up keep-out area

When the chip is in a transition from active to Deep Sleep, Power Down, or Deep Power Down, wake-up events are not captured and they will block further wake-up events from propagating. The time window for this transition is 6 μ s and is not affected by the chip clock speed. After a wake-up event is received during the PMC transition, the chip can only recover by using an external hardware reset or by cycling power.

Make sure that a wake-up signal is not received during the Deep Sleep, Power Down, or Deep Power Down transition period. An example circuit to work around this could include an external 6 μ s one shot which could be triggered via software using a GPIO line when entering Deep Sleep, Power Down, or Deep Power Down mode. The one-shot's output could be used to gate the wake-up signal(s) to prevent receiving a wake-up signal during the PMC transition period. Depending on the system design, it may also be needed to latch the wake-up signal(s) so that they will still be present after the one-shot's 6 μ s time-out.

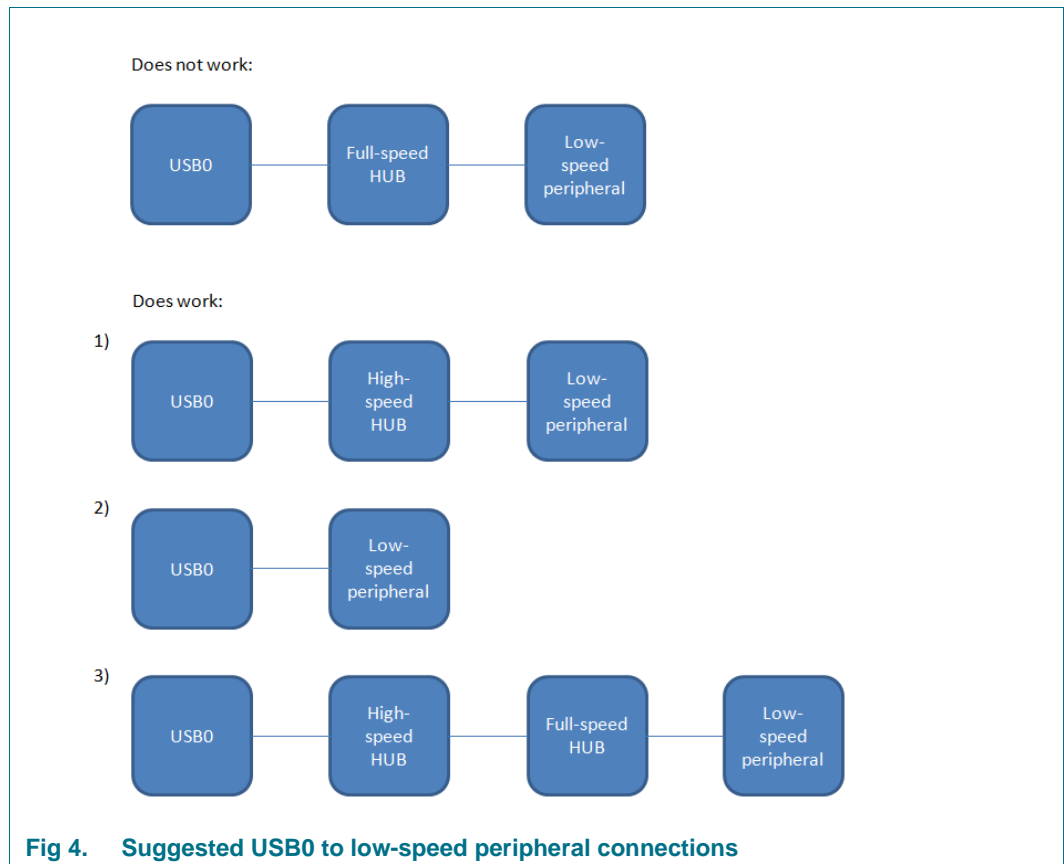
Fig 4. Suggested USB0 to low-speed peripheral connections

The USB controller called USB0 is unable to communicate with a low-speed USB peripheral in host mode when there is a full-speed hub directly connected to the USB0 port and a low-speed peripheral is connected in the tree somewhere below this full-speed hub. Only USB0 has this problem; the other USB controller, USB1 does not.

There is no work-around for this problem. It is suggested that the low-speed USB peripheral is either connected directly to USB0 or a high-speed hub is placed between that peripheral and USB0.
