# ES\_LPC4370/50/30/20/10

Errata sheet LPC4370, LPC4350, LPC4330, LPC4320, LPC4310

Rev. 6.9 — 8 April 2016

Errata sheet

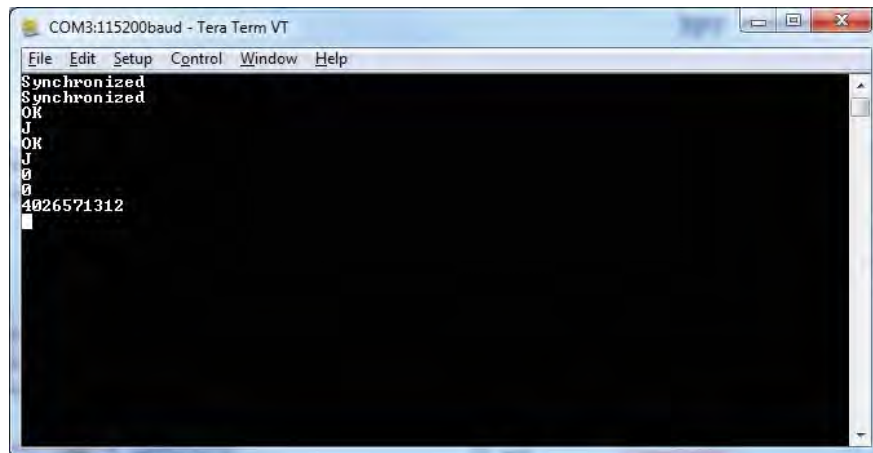
**Incorrect example:**

The 'J' command in ISP mode should return an error code, followed by an ASCII string representation of the part ID, followed by a 0. However what is actually returned is the error code, followed by a 0, followed by an ASCII string representation of the part ID. The problem is the last two items returned are swapped.

There is no work-around for this problem.

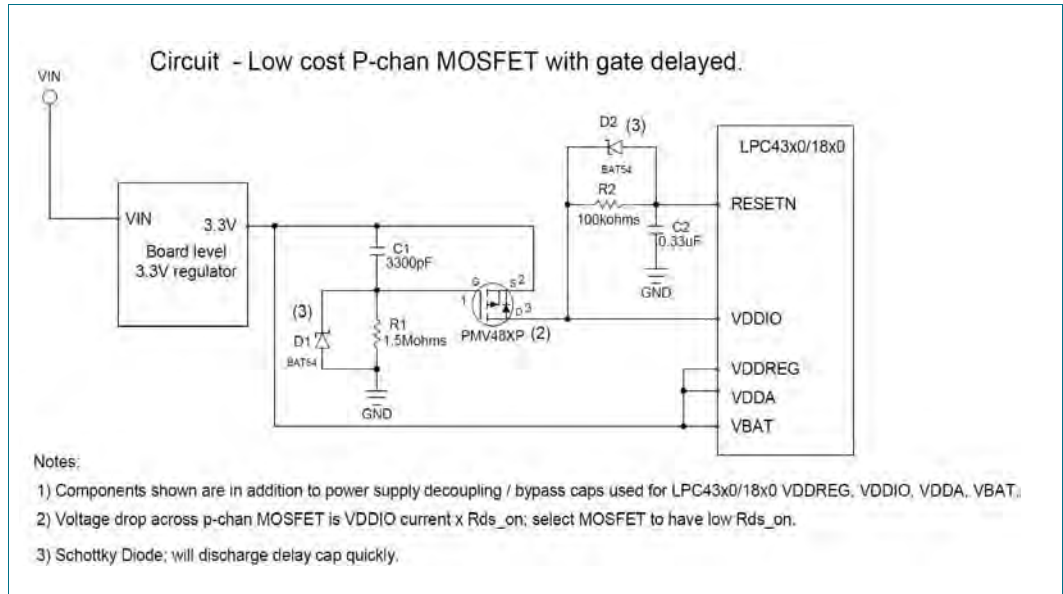
On all packages, repeated power cycling of the device may cause erroneous programming of the OTP banks. During ramp-up, the VDDREG supply voltage does not have enough time to settle and initialize the OTP controller before valid programming voltage is reached on the VPP pin. This may cause accidental programming of the OTP banks. Accidental programming of the OTP banks does not occur during Power-down of the supply voltage.

The following circuit diagram is an example that shows the P-channel MOSFET with the gate delayed and the R-C delay circuit connected to the RESETN pin.

- When OTP programming is not required, the VPP pin should be left as No-Connect (NC) because the VPP and VDDIO pins are separate.
- When OTP programming is required, do not tie VPP pin to VDDREG, VDDIO and VDDA pins. The voltage on the VPP pin should be delayed by 2 ms after the power supply on the VDDREG, VDDA, and VDDIO pins reaches the operating voltage level.

- Do not tie VDDIO to VDDREG and VDDA pins. The power supplied to the VDDIO pin should be delayed by 2 ms after the power supply on the VDDREG and VDDA pins stabilizes at the operating voltage level. The signal to the RESETN pin must also be delayed by 2 ms after the power supply on the VDDIO pin stabilizes at the operating voltage level.

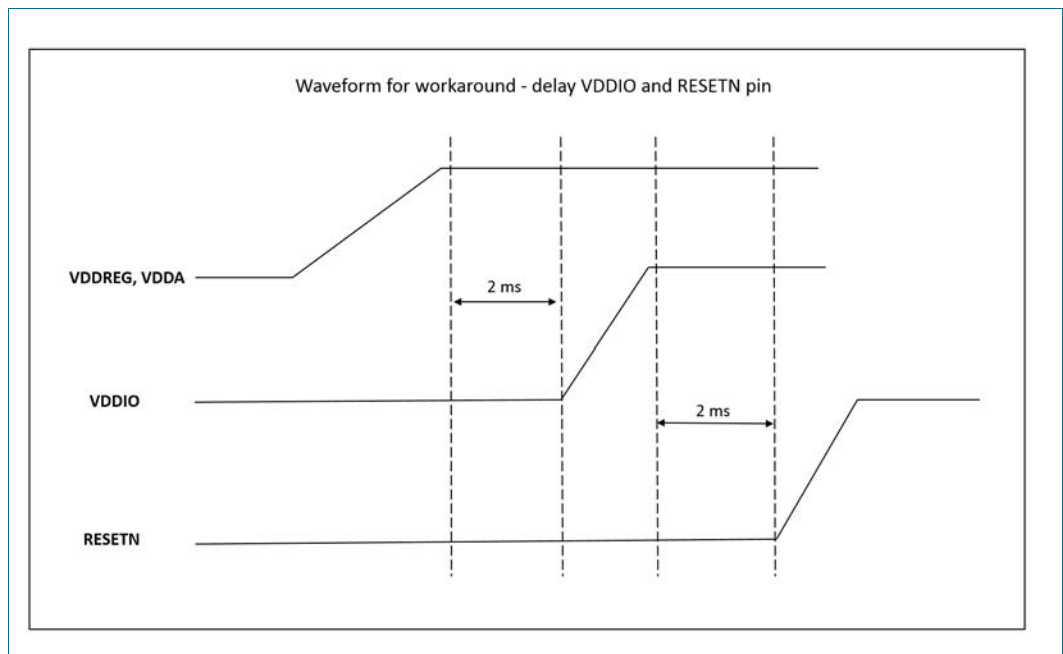
The following diagram shows the waveform for the work-around.

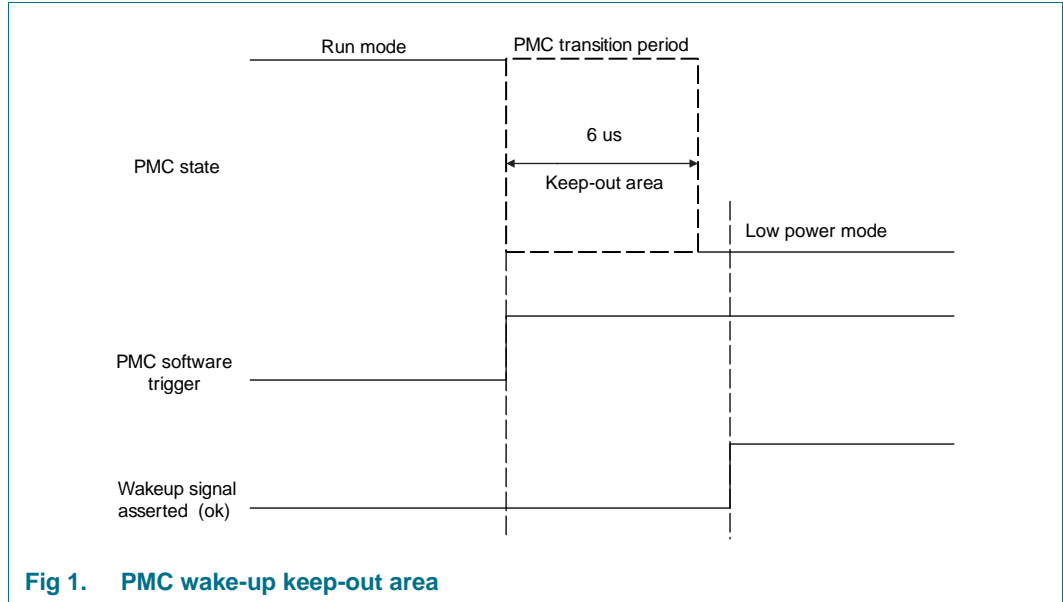
Fig 1. PMC wake-up keep-out area

When the chip is in a transition from active to deep Sleep, power down, or deep power down, wake-up events are not captured and they will block further wake-up events from propagating. The time window for this transition is 6  $\mu$ S and is not affected by the chip clock speed. After a wake-up event is received during the PMC transition, the chip can only recover by using an external hardware reset or by cycling power.

Make sure that a wake-up signal is not received during the deep sleep, power down, or deep power down transition period. An example circuit to work around this could include an external 6  $\mu$ S one shot which could be triggered via software using a GPIO line when entering deep sleep, power down, or deep power down mode. The one-shot's output could be used to gate the wake-up signal(s) to prevent receiving a wake-up signal during the PMC transition period. Depending on the system design, it may also be needed to latch the wake-up signal(s) so that they will still be present after the one-shot's 6  $\mu$ S time-out.

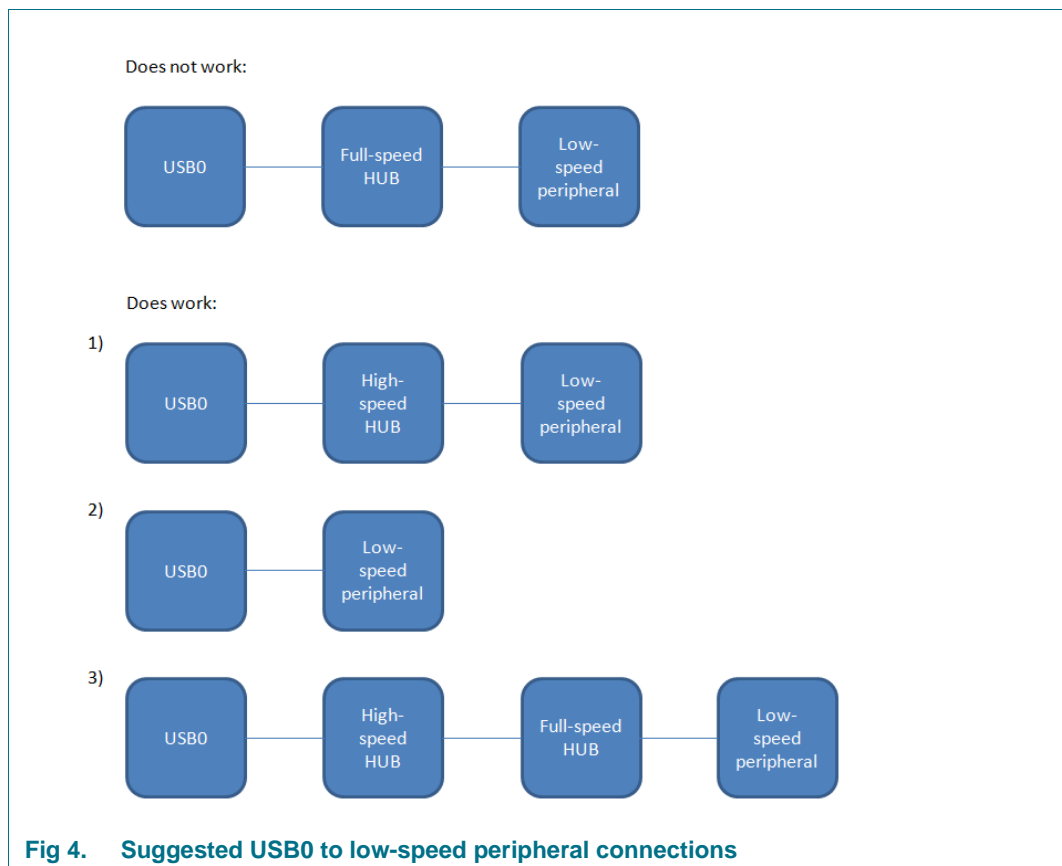
**Fig 4. Suggested USB0 to low-speed peripheral connections**

The USB controller called USB0 is unable to communicate with a low-speed USB peripheral in host mode when there is a full-speed hub directly connected to the USB0 port and a low-speed peripheral is connected in the tree somewhere below this full-speed hub. Only USB0 has this problem; the other USB controller, USB1 does not.

There is no work-around for this problem. It is suggested that the low-speed USB peripheral is either connected directly to USB0 or a high-speed hub is placed between that peripheral and USB0.
